DEPARTMENT OF TRANSPORTATION**DIVISION OF ENGINEERING SERVICES**

Contract #: 04-0120F4Cty: SF/ALA Rte: 80 PM: 13.2/13.9File #: 1.28**WELDING INSPECTION REPORT****Resident Engineer:**Siegenthaler, Peter**Address:** 333 Burma Road**City:** Oakland, CA 94607**Report No:** WIR-016812**Date Inspected:** 14-Sep-2010**Project Name:** SAS Superstructure**OSM Arrival Time:** 630**Prime Contractor:** American Bridge/Fluor Enterprises, a JV**OSM Departure Time:** 1500**Contractor:** American Bridge/Fluor Enterprises, a JV**Location:** Job Site**CWI Name:** See below**CWI Present:** Yes No**Inspected CWI report:** Yes No N/A**Rod Oven in Use:** Yes No N/A**Electrode to specification:** Yes No N/A**Weld Procedures Followed:** Yes No N/A**Qualified Welders:** Yes No N/A**Verified Joint Fit-up:** Yes No N/A**Approved Drawings:** Yes No N/A**Approved WPS:** Yes No N/A**Delayed / Cancelled:** Yes No N/A**Bridge No:** 34-0006**Component:** SAS OBG**Summary of Items Observed:**

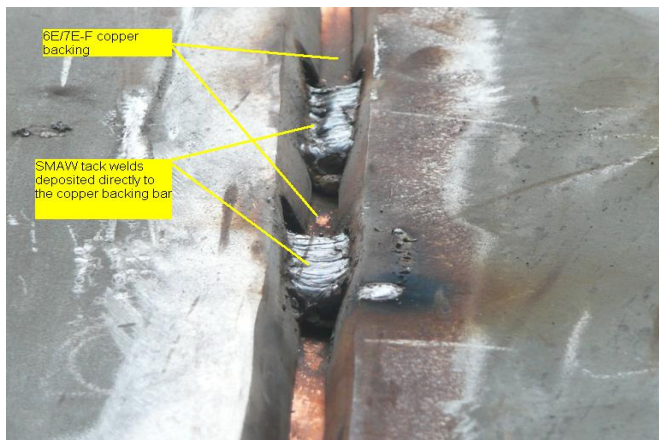
The QA Inspector randomly observed the ABF welder identified as Xiao Jian Wan begin setting up to perform the shielded metal arc welding (SMAW) root/fill pass. The QA Inspector randomly performed a visual inspection of the fit up and dimensional requirements of the weld joint. The QA Inspector noted the fit up including the bevel angle, planar alignment and root opening appeared to be in general compliance with the contract requirements. The QA Inspector did observe the backing material utilized for the weld joint was a copper bar. The QA Inspector asked the QC Inspector Tom Pasqualone what Welding Procedure Specification (WPS) was being utilized to perform the welding. The QC Inspector informed the QA Inspector the WPS designation was identified as ABF-WPS-D1.5-1040-B. The QA Inspector reviewed the above identified WPS and noted the WPS identified as ABF-WPS-D1.5-1040-B requires A709 Grade 50 steel backing and not a copper bar. The QA Inspector randomly observed the ABF welder begin the SMAW root pass by welding subsequent tack welds intermittently through out the weld joint. The QA Inspector noted the tack welds consisted of a root pass, and subsequent weld layers were welded in addition. The QA Inspector noted the ABF welder appeared to be utilizing a weave type welding method. The QA Inspector randomly observed and noted the while the ABF welder was utilizing the weave type method of welding, it did appear the welding arc was in direct contact with the copper bar during the SMAW process. The QA Inspector donned a welding hood and randomly observed the welding arc which did appear to be in direct contact with the copper backing. The QA Inspector randomly observed the SMAW parameters and they

were 145 Amps while utilizing 5/32" E7018 low hydrogen electrodes. The QA Inspector randomly observed the ABF welder did continue the SMAW for the remainder of the QA Inspectors shift. The QA Inspector noted and incident report was written and submitted for the above identified non conforming issue.

The QA Inspector informed the QC Inspector Tom Pasqualone the WPS being utilized for the welding at 6E/7E-F was not qualified to use copper backing in the weld joint. The QC Inspector informed the QA Inspector he was aware the copper backing was not qualified in the WPS identified as ABF-WPS-D1.5-1040B. The QA Inspector informed the QC Inspector an incident report would be written and submitted for the above identified non conforming item in regards to the copper backing bar.
